Vapor Release Research

Presented by
Gary S. Lynn, P.E.

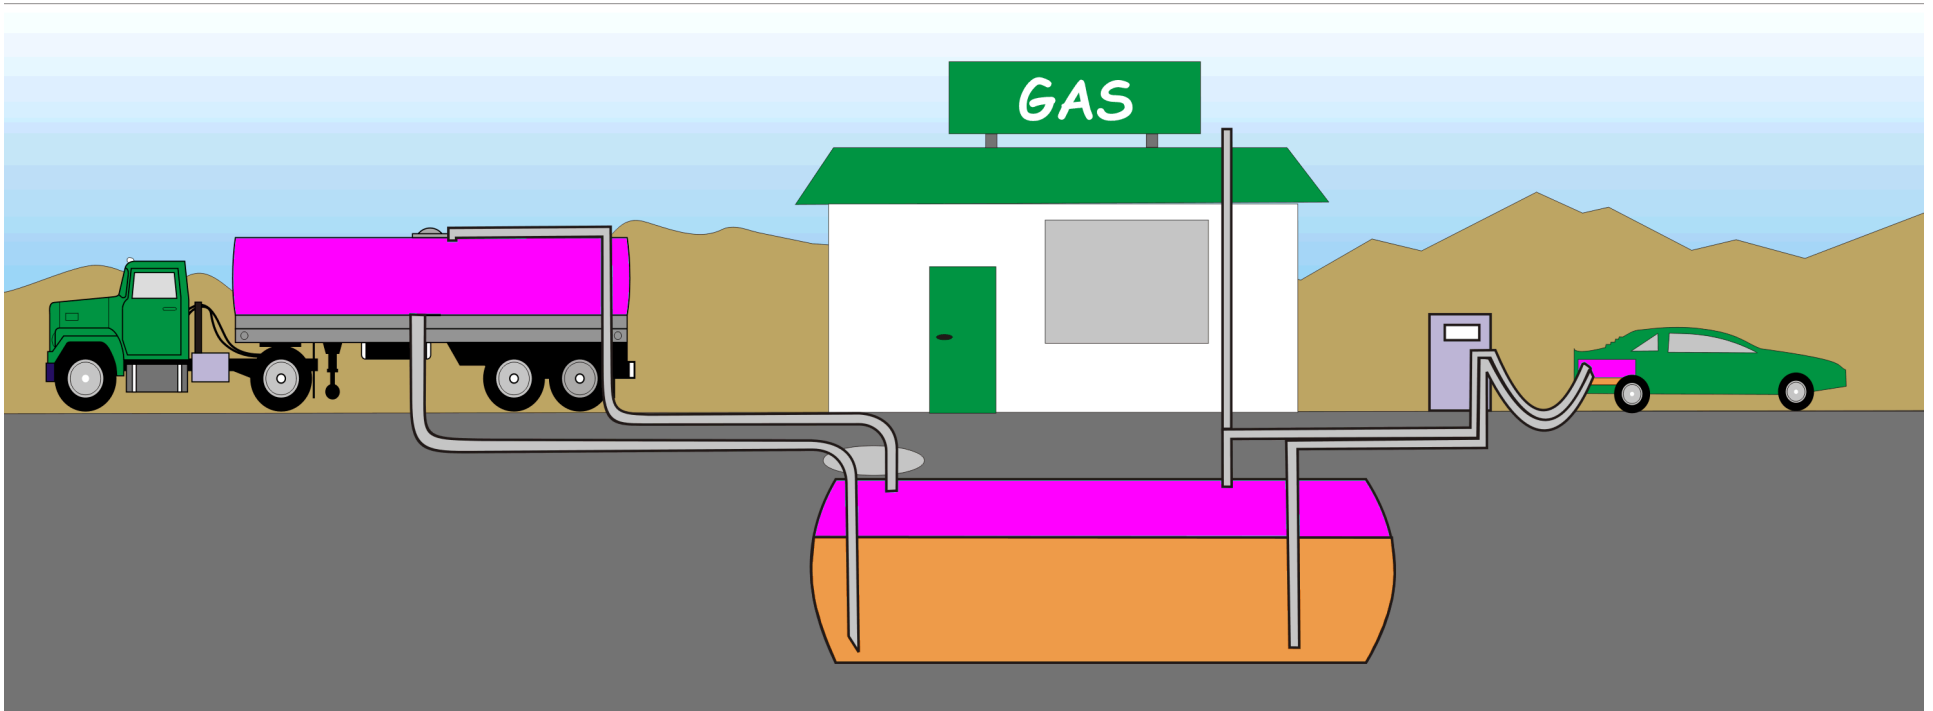
UST Pressurization

Stage I - Vapor Recovery Slower than UST Filling

Stage II - Higher Volume of Vapors Recovered than Liquid Pumped ($A/L > 1$).

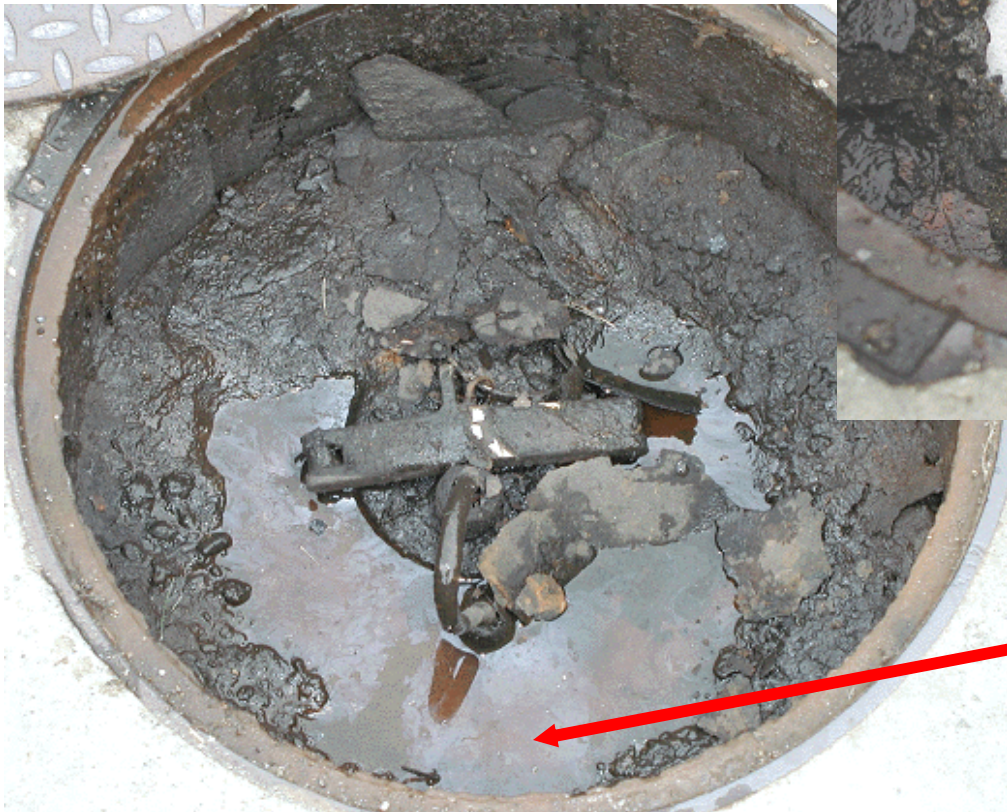
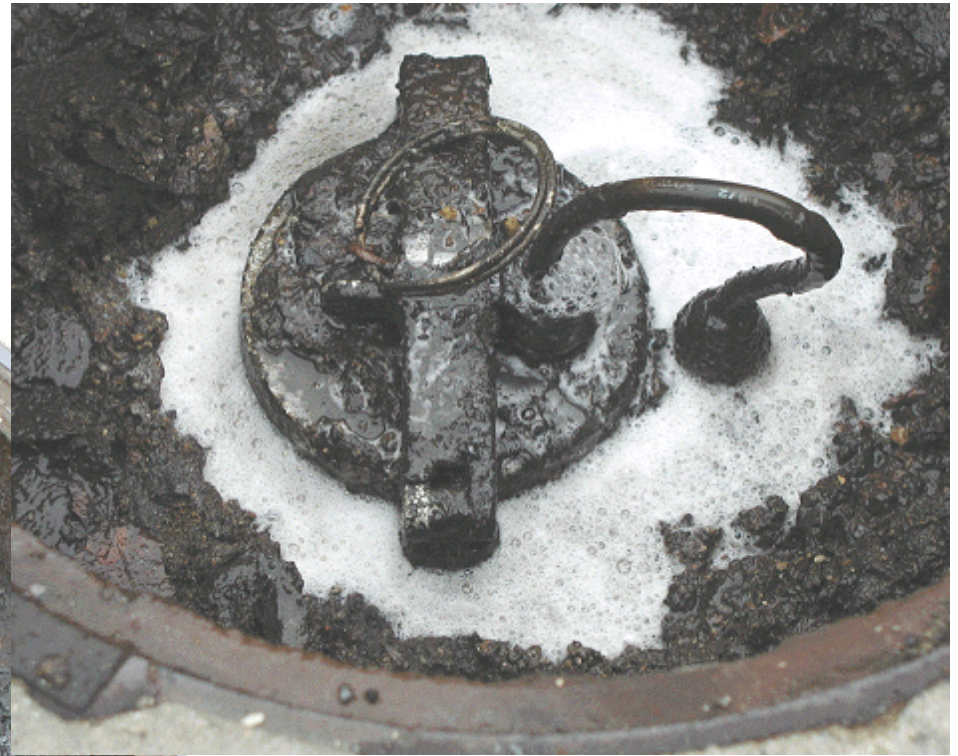
Leaky ATG

Sheen on water

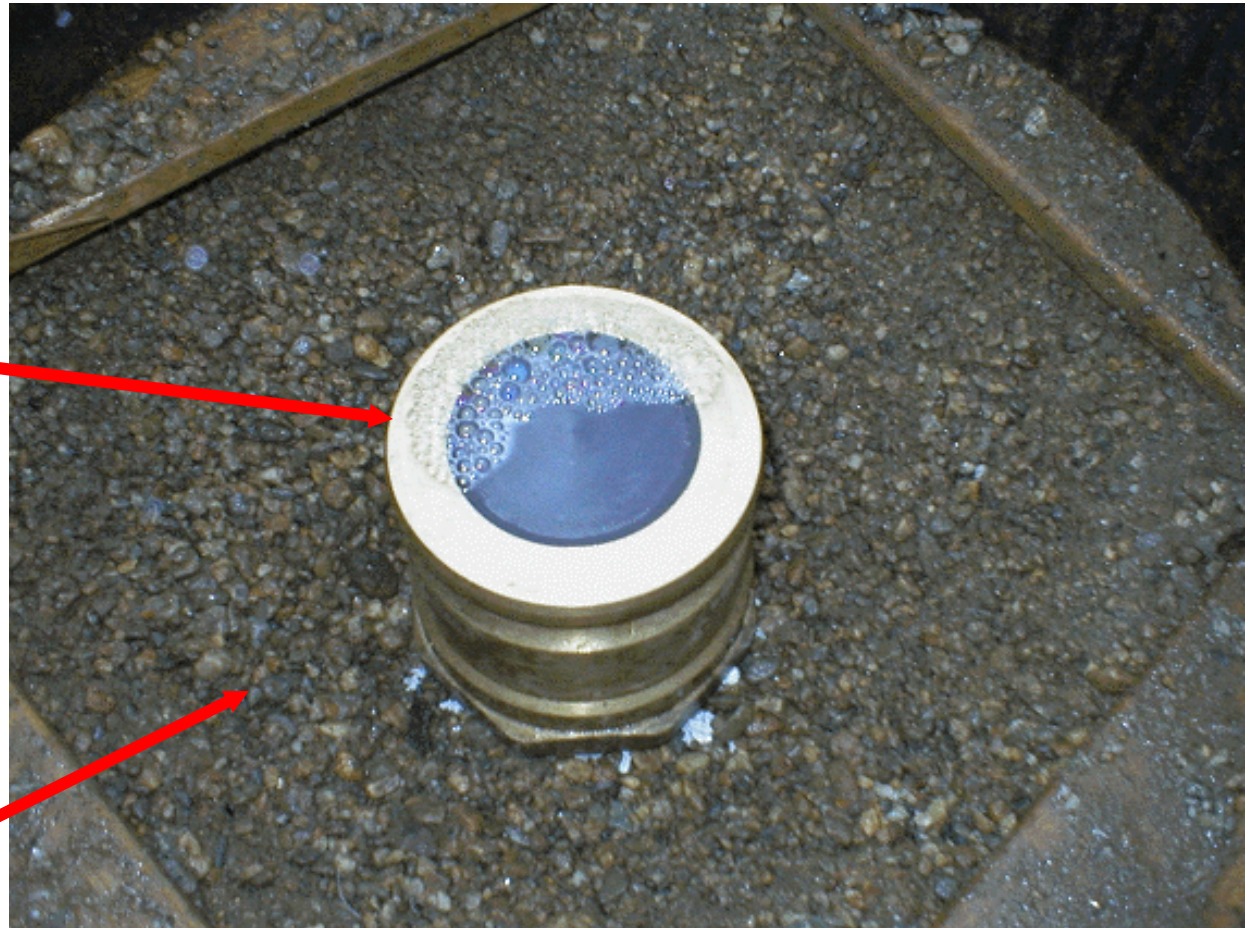
Dry Break Leak

**Leak in new,
just out of box,
dry break**

UST gravel pack

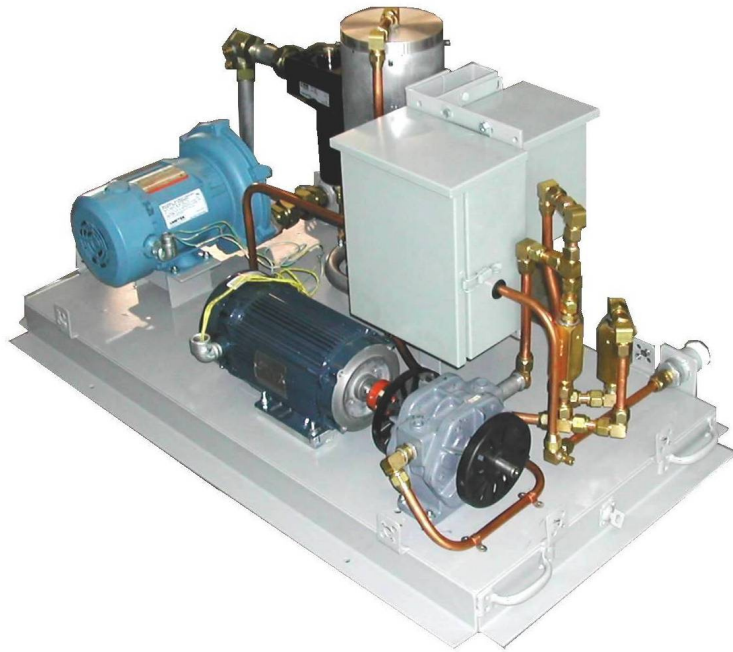
VST/ARID Vapor Processing Systems

- **Pressure Management**
- **Lower Product Evaporative Losses**

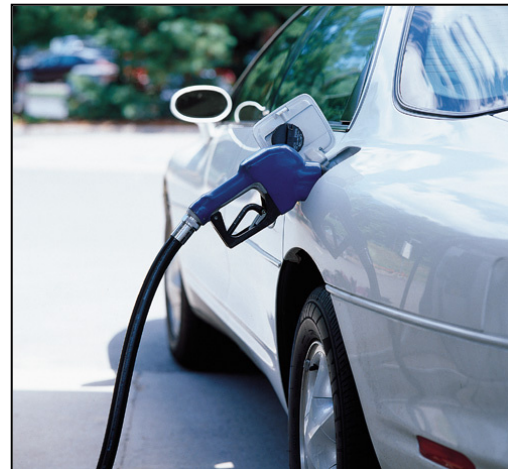
Healy ORVR Compatible Nozzles

- **Reduced A/L**
- **Lower UST Pressures**
- **Lower Product Evaporative Losses**
